# STEERING COLUMN MOVEMENT IN SEVERE FRONTAL CRASHES AND ITS POTENTIAL EFFECT ON AIRBAG PERFORMANCE

Insurance Institute for Highway Safety

Paper No. 136

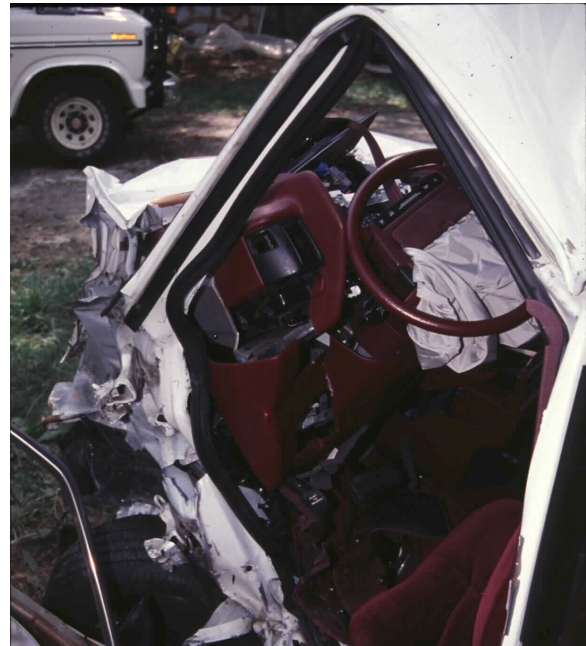
**Figure 5. Steering Column of Dodge Grand Caravan in Crash from IIHS Study was Rotated Upward Considerably**

the driver airbag. The crash involved a 1992 Dodge Grand Caravan driven by a 51-year-old female who was using her lap/shoulder belt. The van crossed the road's centerline into the oncoming lane and collided with a 1994 Toyota pickup truck traveling in the opposite direction. This frontal offset crash was reconstructed with the CRASH3 computer program using damage measurements from both vehicles. The Grand Caravan's delta V was estimated to be 46 km/h, which is similar to CRASH3 delta V estimates using measurements from vehicles crashed at 64 km/h in the IIHS crashworthiness evaluation program (Nolan et al., 1998). The driver of the Grand Caravan died of an unspecified closed-head injury, according to the Virginia medical examiner's report. The only

external injury noted in this and the hospital report was a laceration of the forehead, or forward portion of the scalp. The most likely source of the laceration, and possibly the brain injury, was the steering wheel rim, which was slightly bent and bore marks that may have been caused by the driver's head impact. Measurements of the crashed vehicle indicated the steering column was displaced 19 cm rearward and 6 cm rightward. A suitable reference for vertical displacement was not available, but Figure 5 shows that it was rotated upward considerably. It seems likely, especially noting the early movement of the steering column observed in the re-creation of the NASS case mentioned

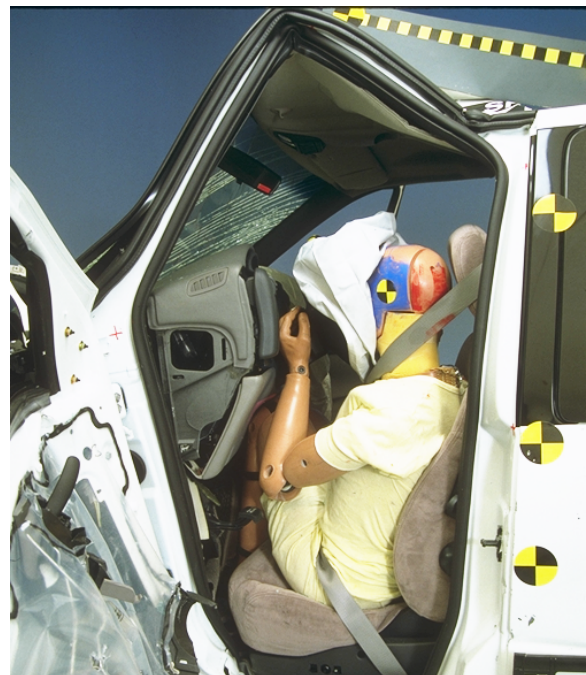
**Figure 6. Steering Column in Pontiac Tran Sport Crashed by IIHS was Rotated Upward 19 cm**

previously, that movement of the column in this crash contributed to the driver's head contacting the steering wheel. Another explanation for the driver's death is suggested by comparison with an IIHS crash test of a different model van, the 1997 Pontiac Trans Sport. The tested Trans Sport and the Grand Caravan from the seven-county study had similar levels of exterior deformation, with maximum crush measuring 98 and 100 cm, respectively. Steering column displacement in the Trans Sport was similar to that observed in the Grand Caravan, with 21 cm longitudinal displacement and 19 cm upward displacement (Figure 6). During the Trans Sport test, the dummy recorded

moderately high neck tension (2.7 kN) and quite high neck bending torque (106 Nm) when its head interacted with the driver airbag on the end of the moving steering column. These forces, although not indicating a certainty of injury, might be associated with an elevated risk of cervical spine or basal skull injury. Thus, contact with the unprotected steering wheel is only one way in which the steering column movement might degrade airbag performance.

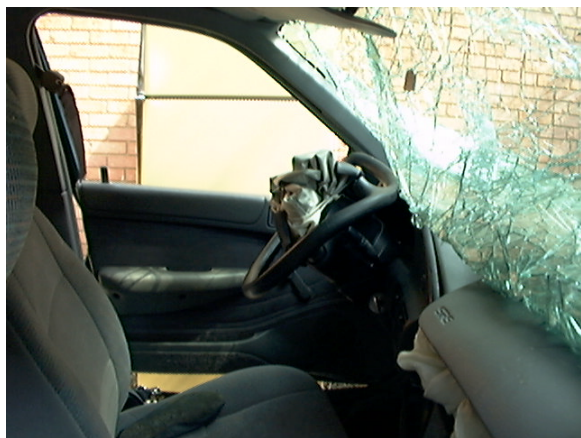
**Figure 7. Steering Column in Ford Escort from 1998 NASS case 49-151A was Rotated Upward Considerably and Bent by Driver Contact**

IIHS researchers recently undertook an examination of frontal crashes of airbag-equipped cars that were fatal to the drivers of those cars (Zuby et al., 2001). The objective of the study was to categorize each crash according to the primary cause of each driver's fatal injuries. The study found that major collapse of the occupant compartment, combined with contacting a specific intruding component, accounted for most driver deaths (41 percent). There also were a large number of cases (21 percent) in which more than one primary cause were equally reasonable explanations for the driver's death. Among these 72 cases, the steering wheel was frequently assigned as an injury source by the NASS investigators. A case from 1998, for example, involved a 1995 Ford Escort driven by a 51-year-old female that collided with a 1988 Honda Accord traveling in the opposite direction (case 49-151A). Despite a rather high estimated delta V (86 km/h), the steering wheel displacement recorded by the investigator (12 cm) was slightly less than the limit imposed by FMVSS 204. Figure 7 shows that in addition to this rearward movement, the column was rotated upward. Still, the steering wheel was bent, suggesting that it was loaded by the driver, who was using the automatic shoulder belt but not the lap belt. Her injuries included broken ribs and significant contusions of the heart and lungs. Another crash (case 11-135J from 1998) involved a severe frontal crash (estimated delta V of 63 km/h) between a 1998 Dodge Dakota pickup and a tree. The 16-year-old driver, who was using his seat belt, died of closed-head injuries for which the NASS investigator did not assign an impact cause. However, comparison with an IIHS crash test of the same model vehicle suggests that movement of the steering column may have led to contact with the steering wheel through the airbag. Delta V estimates from the SMASH computer program suggest that the IIHS 64 km/h frontal offset test was less severe (estimated delta V of 48 km/h) than the NASS crash, yet high neck forces (3.9 kN tension) and head acceleration (163 g) were recorded when the dummy's head contacted the steering wheel. Consequently, with even greater steering column displacement (10 cm rearward, unmeasured upward) than observed in the crash test (5 cm rearward, 19 cm upward), it seems plausible that the driver in the NASS crash sustained his fatal head
